**REPORT OF  
INSPECTION PROCEDURES AND RESULTS  
FOR  
DETERMINING QUALIFICATIONS OF A  
TAX INCREMENT FINANCING DISTRICT  
AS A REDEVELOPMENT DISTRICT**

**Public Works TIF District  
Richfield, Minnesota**

LHB Project No. 130637.00

**January 9, 2014**

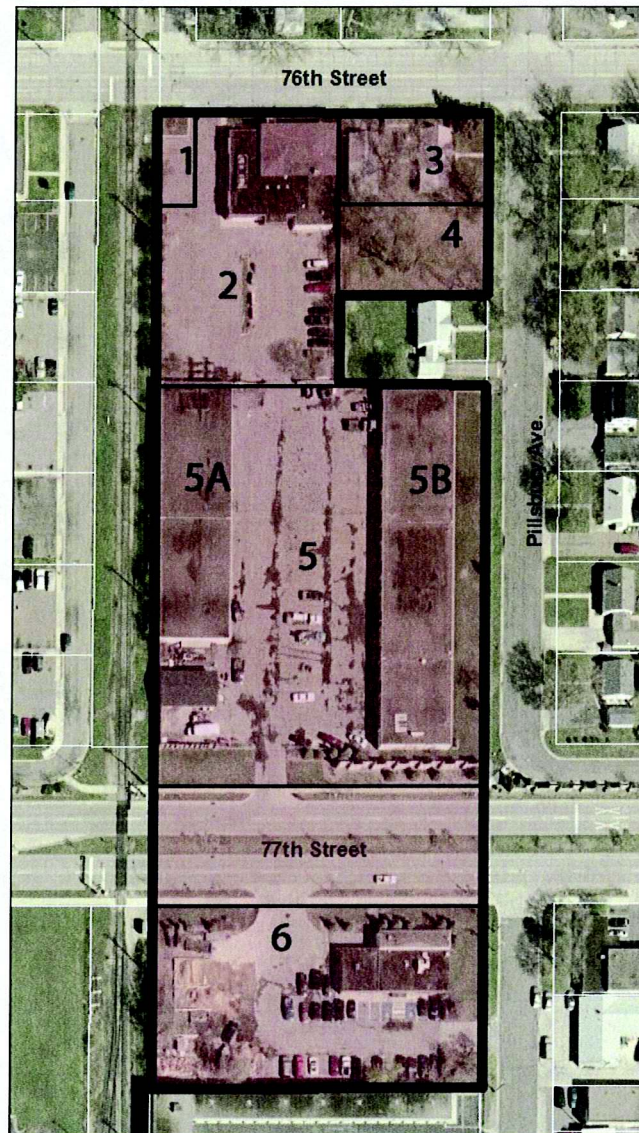
Diagram 1 – Proposed TIF District

LHB was hired by the City of Richfield to inspect and evaluate the properties within a Tax Increment Financing Redevelopment District (“TIF District”) proposed to be established by the City. The proposed TIF District is located immediately South of 76<sup>th</sup> Street on the West side of Pillsbury Avenue, bisected by 77<sup>th</sup> Street (Diagram 1). The purpose of LHB’s work is to determine whether the proposed TIF District meets the statutory requirements for coverage, and whether five buildings on six parcels, located within the proposed TIF District, meet the qualifications required for a Redevelopment District.

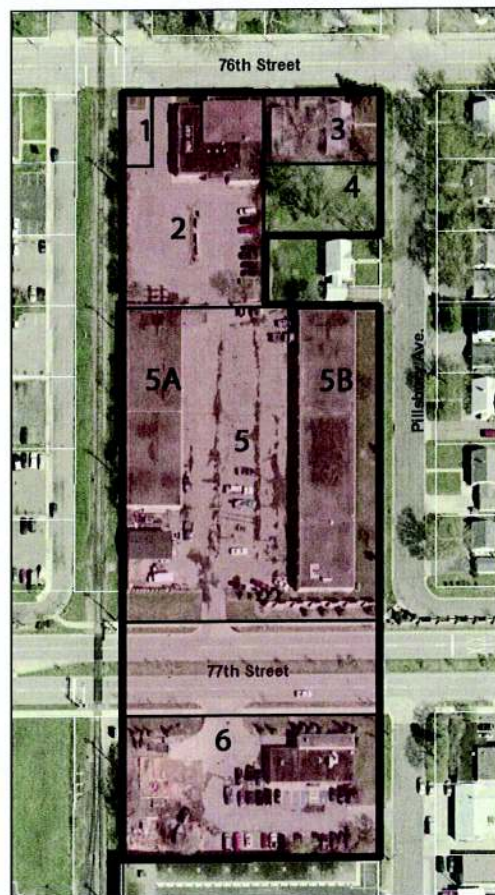
**Diagram 2 – Coverage Diagram**

Shaded area depicts a parcel more than 15 percent occupied by buildings, streets, utilities,  
Paved or gravel parking lots or other similar structures

The proposed TIF District met the coverage test under *Minnesota Statutes, Section 469.174, Subdivision 10(e)*, which resulted in parcels consisting of 95 percent of the area of the proposed TIF District being occupied by buildings, streets, utilities, paved or gravel parking lots, or other similar structures (Diagram 2). This exceeds the 70 percent area coverage requirement for the proposed TIF District under *Minnesota Statutes, Section 469.174, Subdivision (a) (1)*.

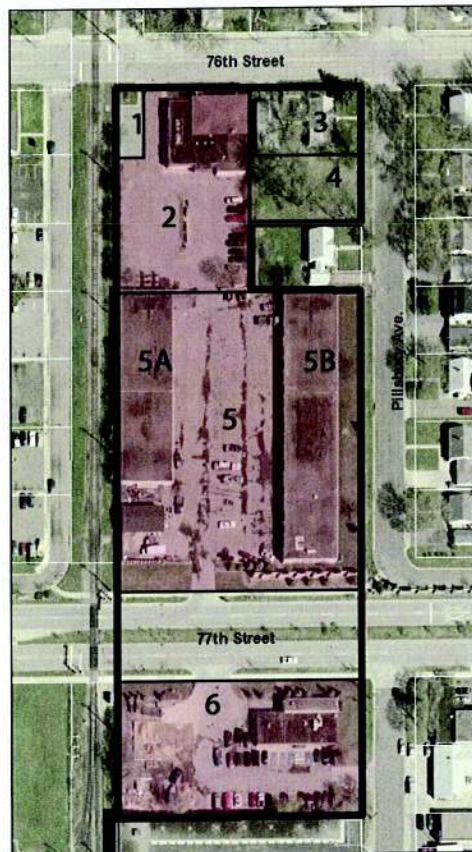
Diagram 3 – Substandard Buildings  
Shaded area depicts parcels with substandard buildings

The substandard buildings are reasonably distributed throughout the geographic area of the proposed TIF District.
